HYDROFLUX

BAIADA KU-RING-GAI (DISSOLVED AIR FLOTATION AT A POULTRY FURTHER PROCESSING PLANT IN SYDNEY)

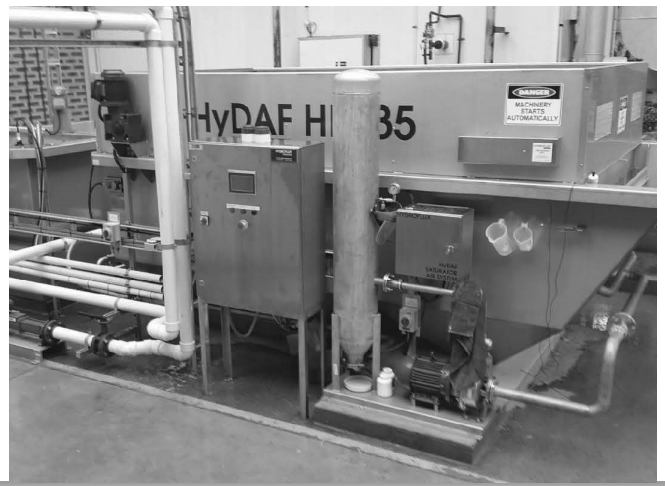
The Hydroflux HyDAF HD-35 was located on a concrete slab adjacent to the existing treatment plant allowing minimal disruption to the treatment process during commissioning.

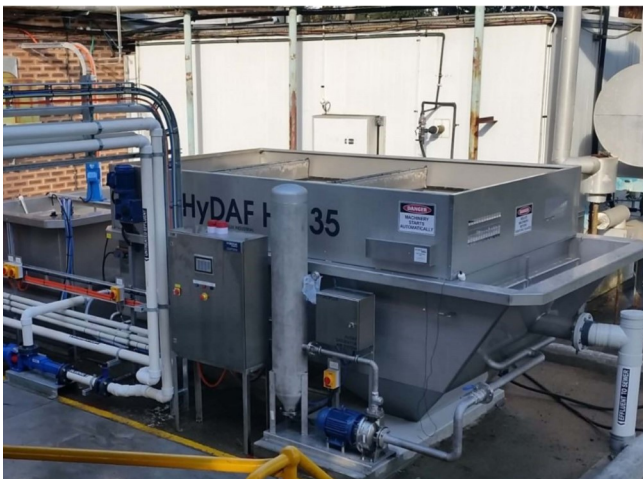
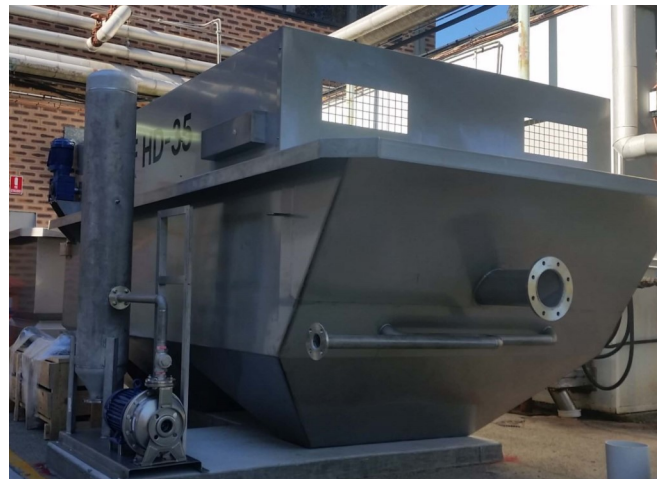
A large reaction tank was provided to ensure that the chemical treatment process and pH control is optimized.

The system was designed and installed by Hydroflux as a complete turnkey project. Over 98% of suspended solids and grease are removed from the wastewater stream representing a BOD reduction of greater than 70%
