CLEVER BOLTED ROADTRAIN® PACKAGED PLANT FOR MORO VILLAGE STP

Another of our successful bolted Roadtrain® installations was completed at Moro village within the Oilsearch mining lease in the Papua New Guinea southern highlands, once again demonstrating:

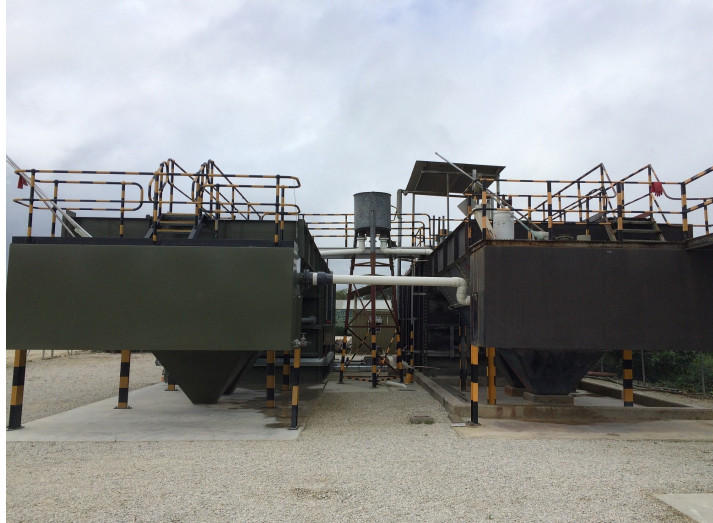
The plant is based on the intermittent aeration treatment process.

The incoming sewage is aerated in the aeration tank. During the aeration phase the bacteria enter an aerobic state to oxidise the carbonaceous pollutants. When the blowers cycle off the tank enters into the anaerobic state and bacteria convert nitrites to nitrates.

Aerated liquor is decanted from the tank via a control float and discharged into the acquiescent zone of the clarifier where treatment is split into a sludge train and an effluent train.

The bolted panel Roadtrain® is a flat pack system reducing logistical issues for sites with limited road access or absence of cranes. Installation crews have used Hiab crane trucks on a number of occasions and in one instance by Vertol helicopter replacing cranes.

In the Moro case, the plant installed in 2015 was a capacity building addition by adding a flow splitter to augment an existing identical Hydroflux bolted Roadtrain® installed in 1990.
